103-80-35

Nossuk Bay Head Stream

6-18-78.

Larson, Berg

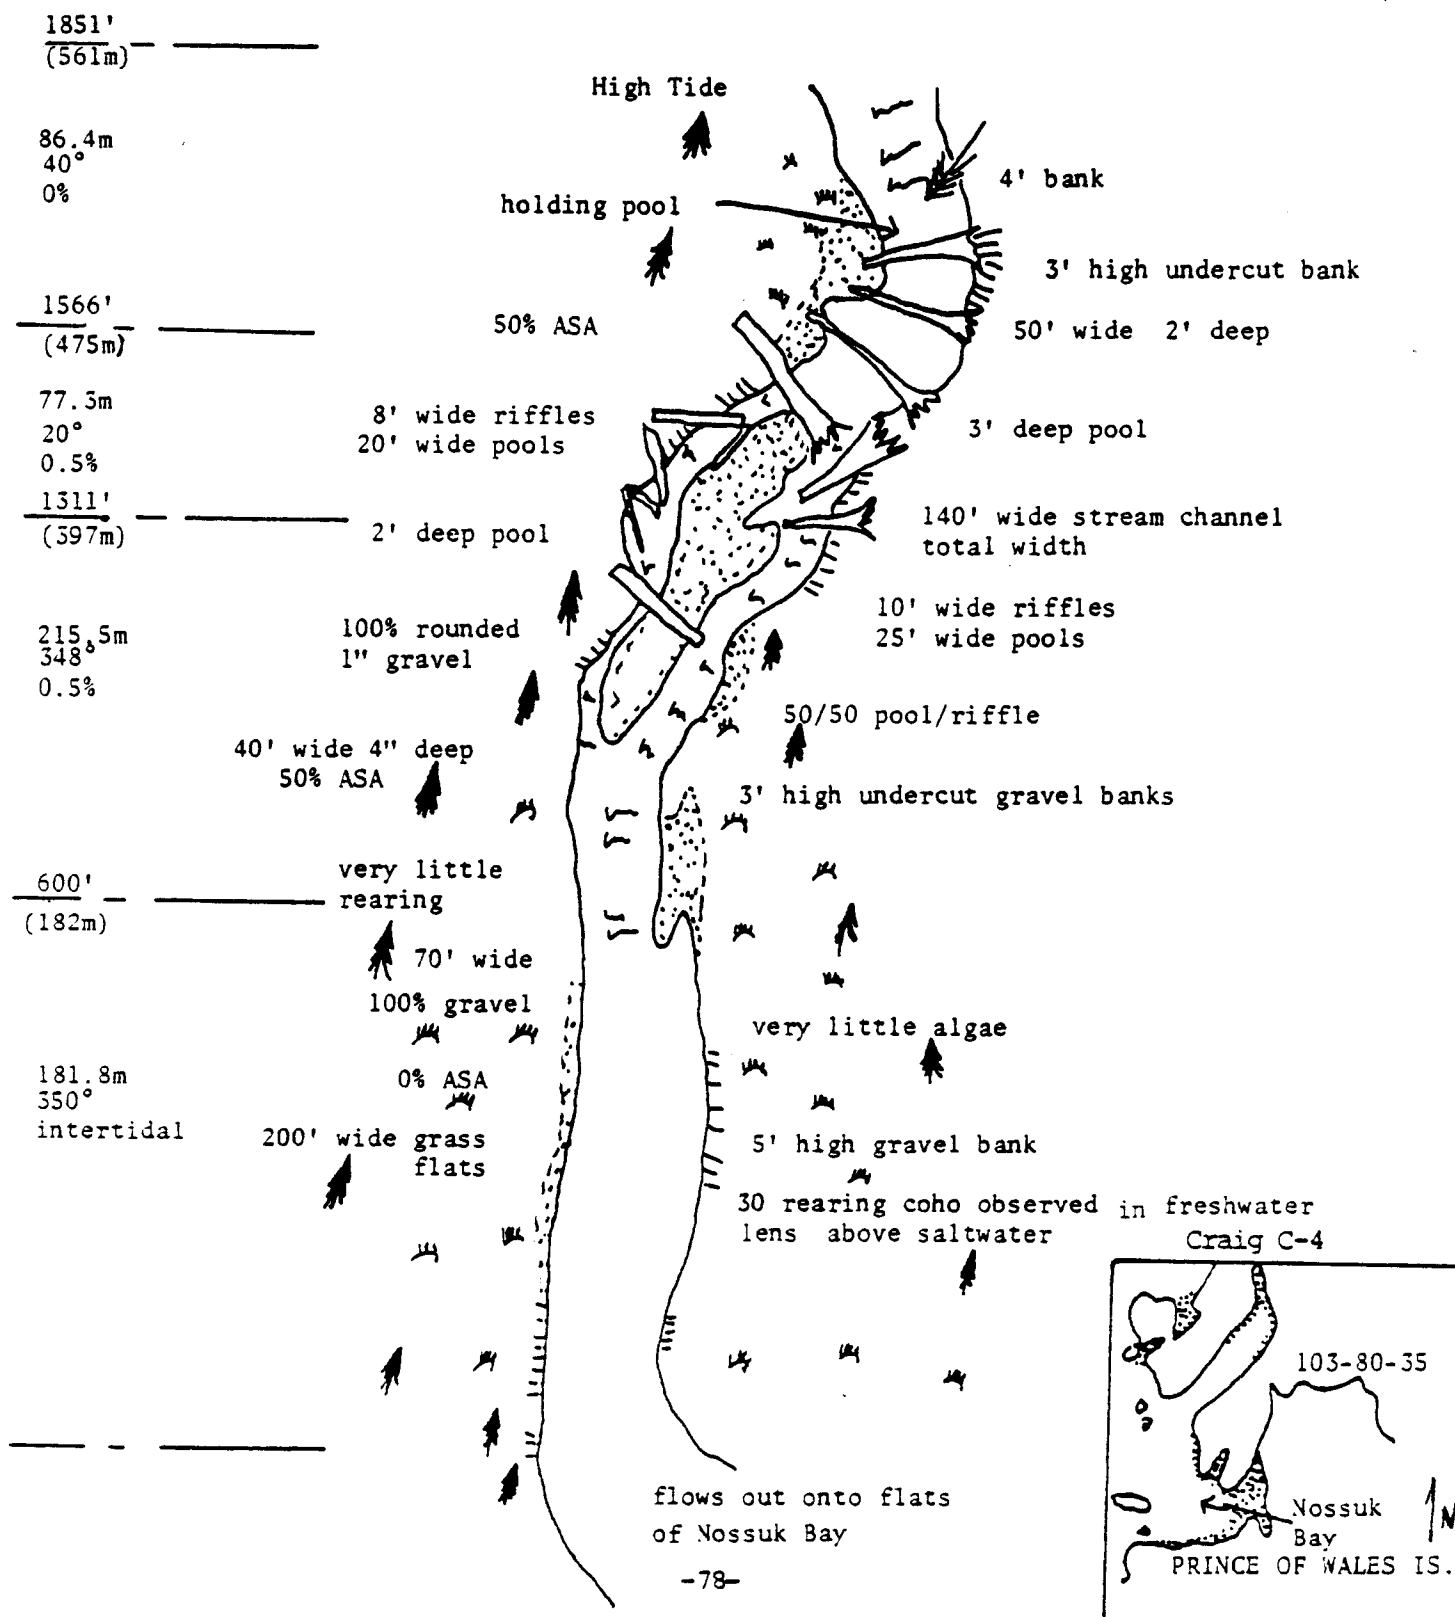
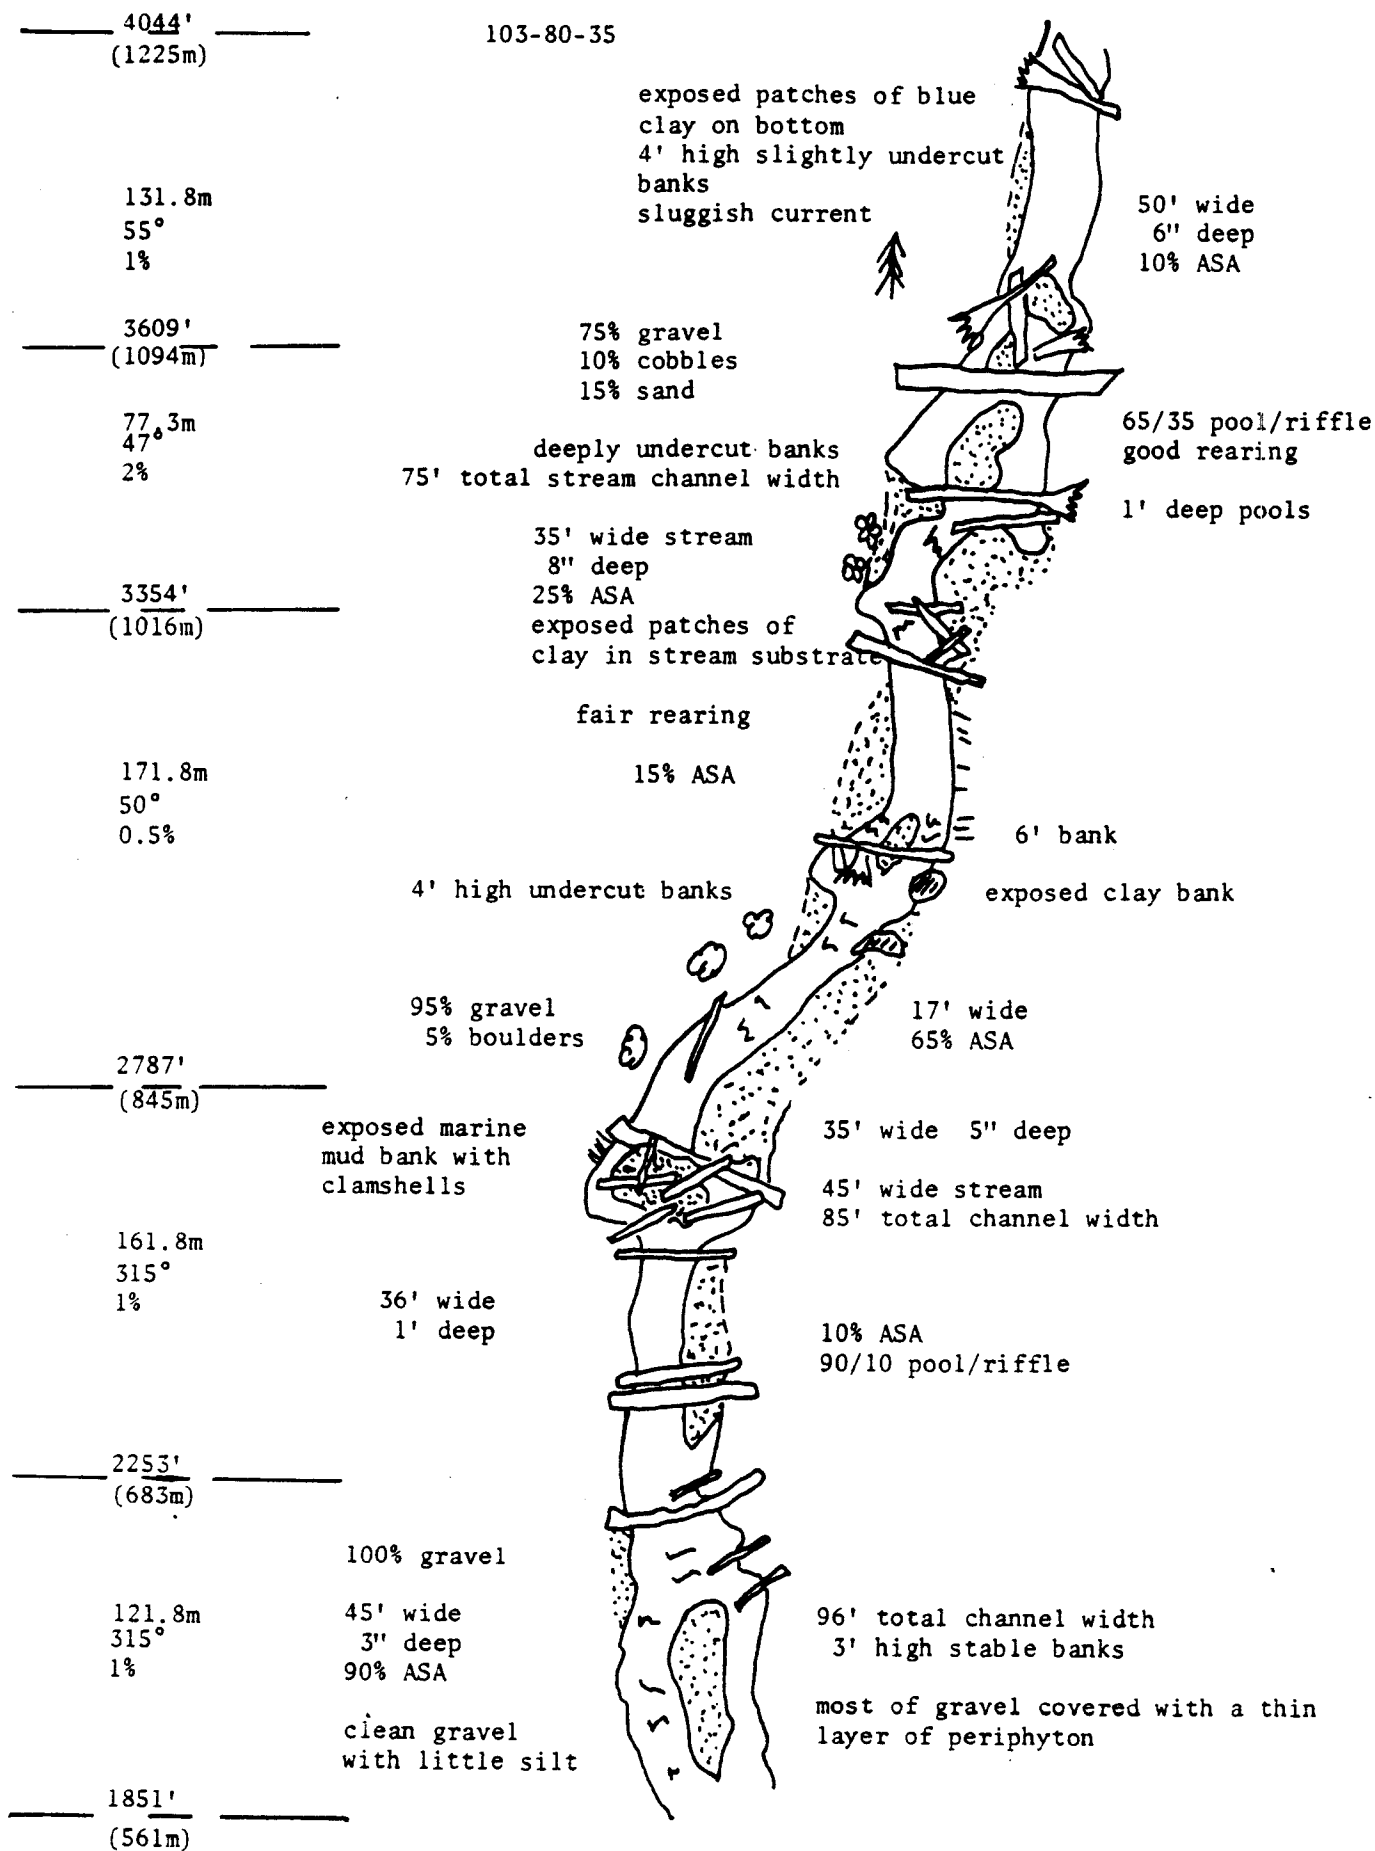
103-80-35

7410'
(2245m)

61.8m
120°
0%

1 beaver observed
5% ASA
salmon bones on bank

7206'
(2184m)

50.9m
85°
0%

4' deep pool
deeply undercut banks
supported by roots of
large spruce

30' wide flood channel
100' wide flood plain

20' wide
beginning of beaver dam

0% ASA
large
spruce on
island

20' wide
25% ASA

isolated pools with
rearing coho

7038'
(2133m)

119.1m
65°
1%

50/50 pool/riffle
50% ASA

flood plain

30' bedrock cliff

1' deep pool
thick brush
70% ASA
12' wide 2" deep
rounded gravel

6645'
(2014m)

140.9m
0°
0%

bedrock

3' wide

3' stable banks

6180'
(1873m)

104.5m
20°
0.5%

50' flood plain

35' wide 2' deep
0% ASA

thick brush

start of beaver dam

15' wide 90% ASA

5835'
(1768m)

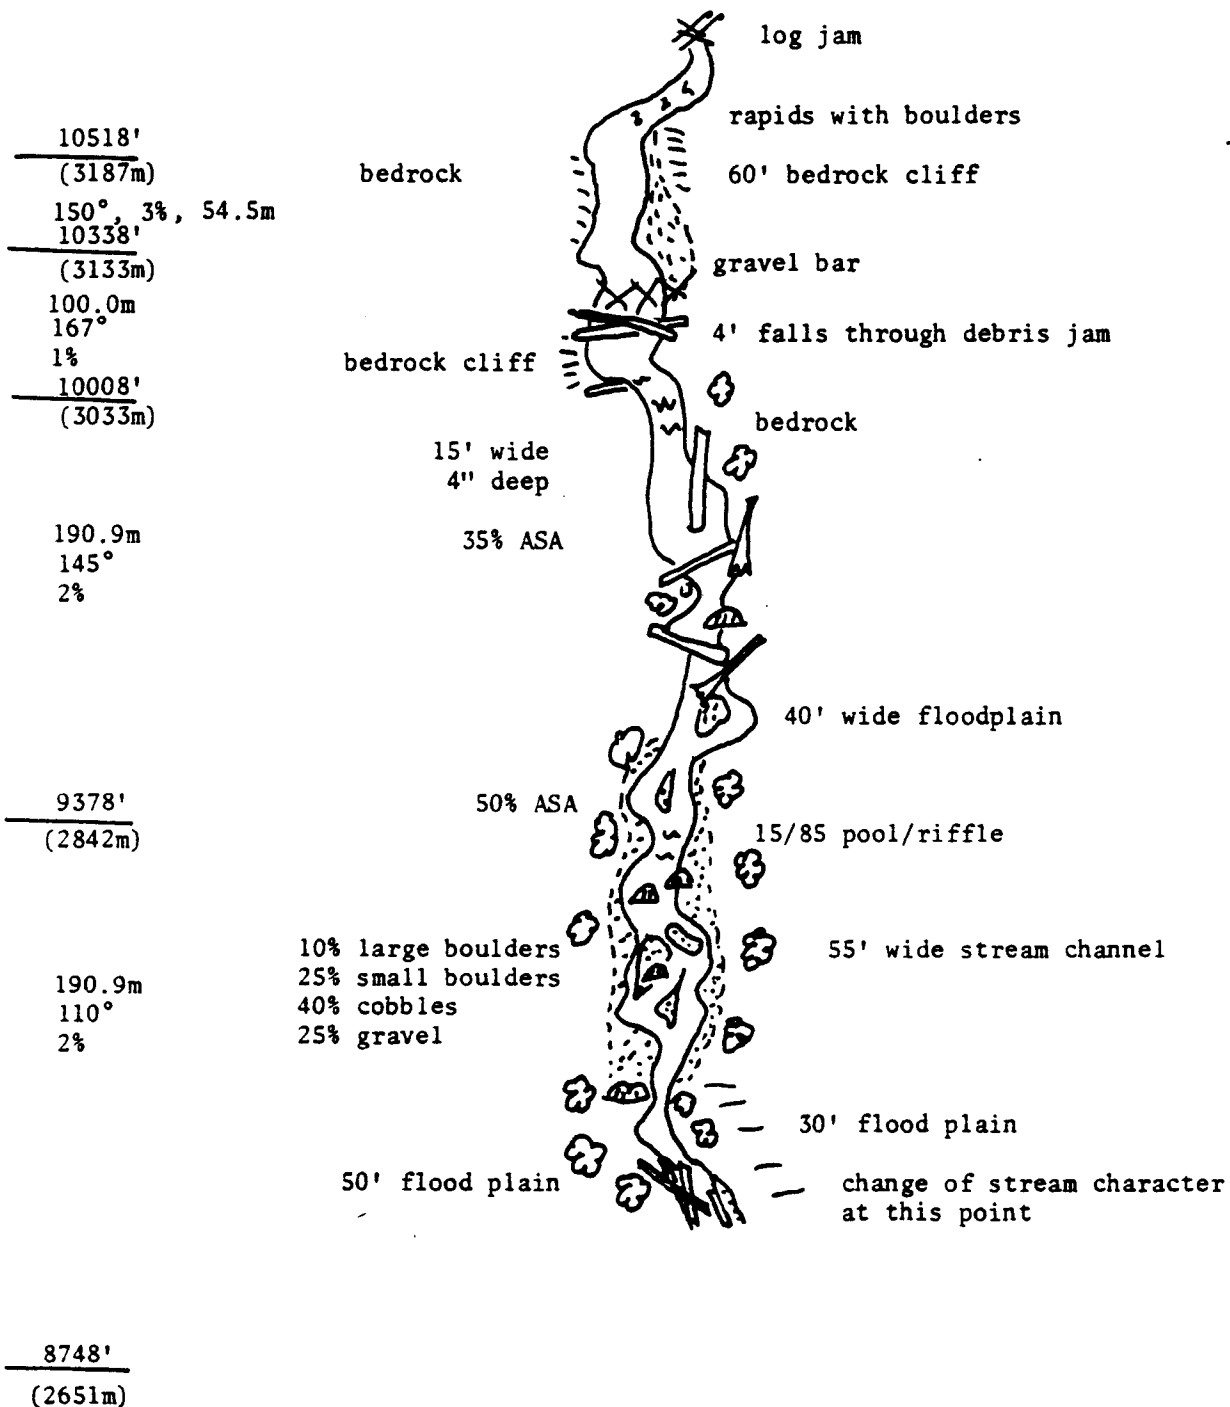
Stream is incised between 100% slopes with bedrock outcrops. Gradient is approximately 3 - 4%. Substrate consists of boulders and bedrock with little gravel. Poor rearing and very little spawning.
